### Inspection Report Minerals Regulatory Program October 26, 2011

<b>Mine Name:</b> Lost Sheep Mine	<b>Permit Number:</b> S/023/0029
<b>Operator Name:</b> Michael Provstgaard	<b>Inspection Date:</b> October 26, 2011
<b>Inspector(s):</b> Wayne Western	<b>Time:</b> 12:15 -1:30 PM
<b>Other Participants:</b> none	<b>Mine Status:</b> Active

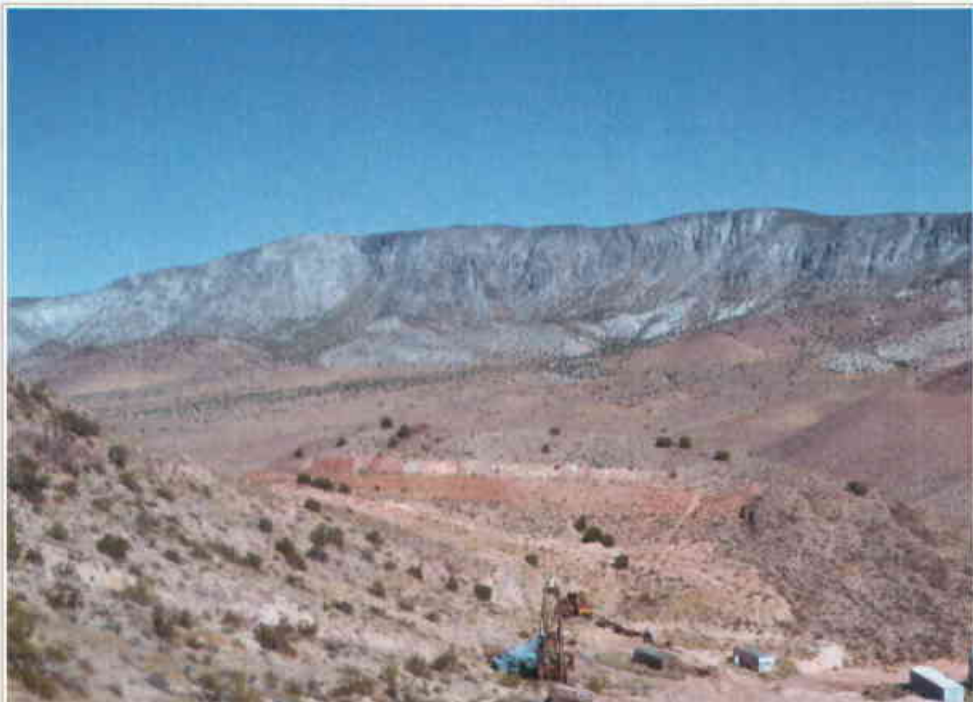
The mine is stable and there is no sign of recent activity. The Operator last reported that mining had occurred in 2006.

Head Frame

The Division should continue to monitor the site.

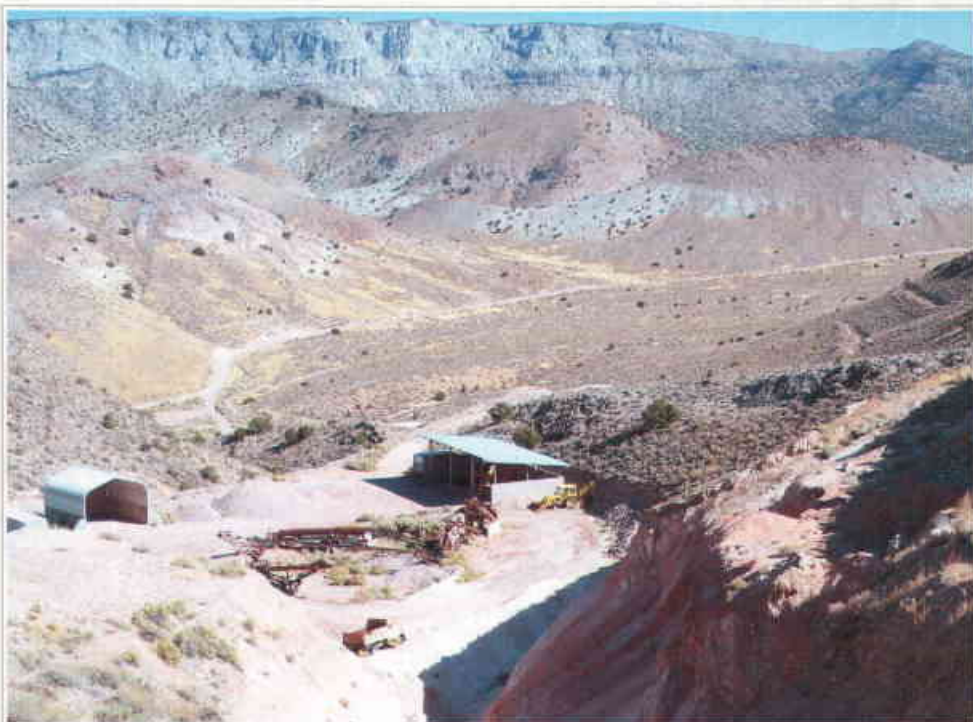
Equipment storage area
